DEPARTMENT OF TRANSPORTATION

Quality Assurance and Source Inspection

Contract #: 04-0120F4Cty: SF/ALA Rte: 80 PM: 13.2/13.9File #: 69.28**WELDING INSPECTION REPORT****Resident Engineer:**Siegenthaler, Peter**Address:** 333 Burma Road**City:** Oakland, CA 94607**Report No:** WIR-017564**Date Inspected:** 20-Oct-2010**Project Name:** SAS Superstructure**OSM Arrival Time:** 1900**Prime Contractor:** American Bridge/Fluor Enterprises, a JV**OSM Departure Time:** 700**Contractor:** Zhenhua Port Machinery Company, Ltd (ZPMC), Changxing Island **Location:** Shanghai, China**CWI Name:** Mr. Xu Tao**CWI Present:** Yes No**Inspected CWI report:** Yes No N/A**Rod Oven in Use:** Yes No N/A**Electrode to specification:** Yes No N/A**Weld Procedures Followed:** Yes No N/A**Qualified Welders:** Yes No N/A**Verified Joint Fit-up:** Yes No N/A**Approved Drawings:** Yes No N/A**Approved WPS:** Yes No N/A**Delayed / Cancelled:** Yes No N/A**Bridge No:** 34-0006**Component:** Tower**Summary of Items Observed:**

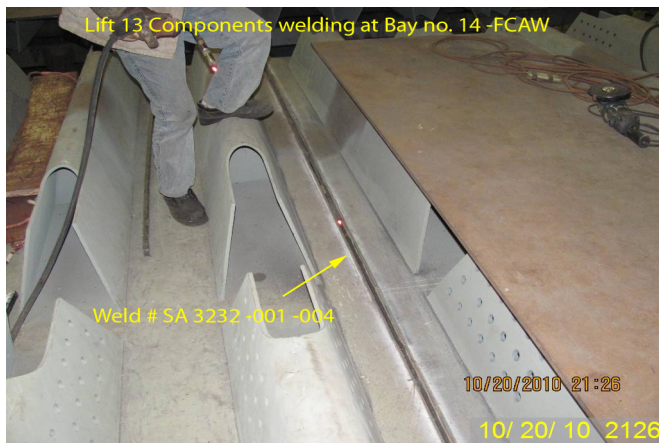
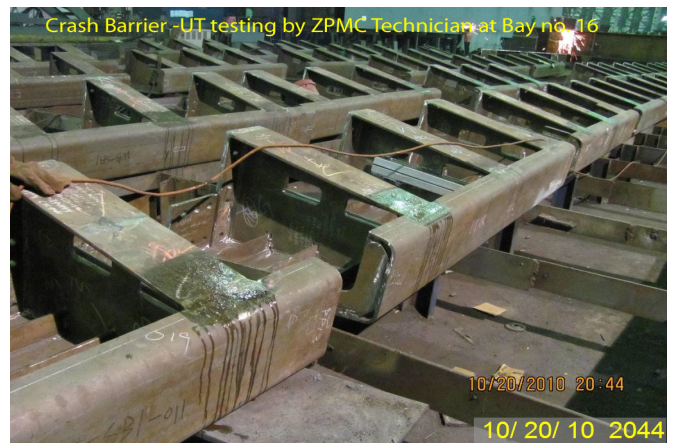
For further information see below pictures:-

Unless otherwise noted, all work observed on this date appeared to be in general compliance with the applicable contract documents.
